**South Tacoma Station  
Access Improvements Project  
Phase 2  
Township No 20 North  
Range No 3 East Will Mer.**

# Appendix E

Built-Environment Survey Results

## South Tacoma Station Access Improvements Project Phase 2

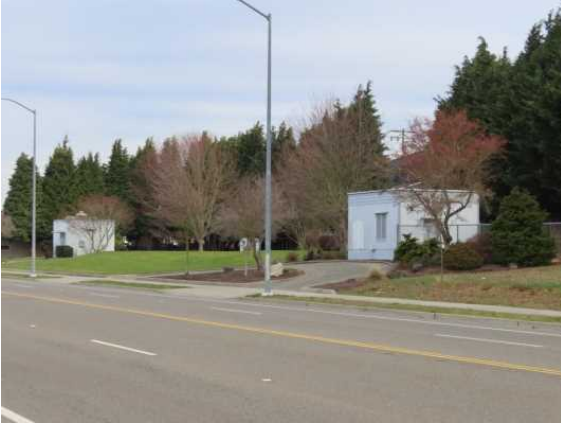
Wells and wellhouses at 4331 S Tacoma Way, view northeast.

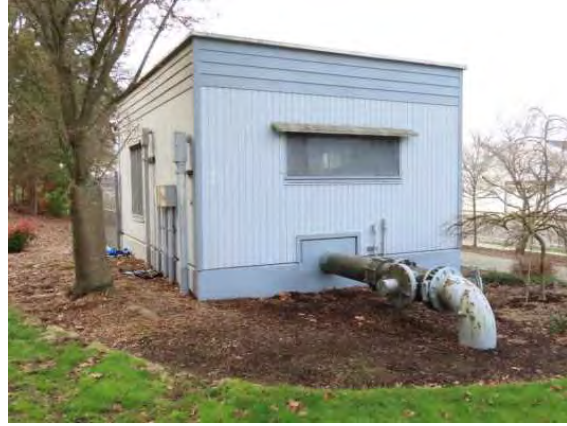
Wellhouse 6 at 4331 S Tacoma Way, view southwest.

Wells and wellhouse 6A and 6B (ca. 1952): Wellhouse 6A and 6B sits on a poured-concrete foundation, is clad in T1-11 with lapped siding at the cornice, and is topped by a flat roof. The building's west elevation includes an off-center sliding window under a small projecting eave. The window is heavily screened. The building's north elevation includes an exterior pipe and a wide screened window under a small projecting eave. The building's rear (east) elevation includes electrical and an additional screened window. The building's south elevation is enclosed by steel fencing. It includes a solid pedestrian door and is connected to exterior piping.

Due to a lack of significance and integrity, Historical Research Associates recommends the wells and wellhouses at 4331 S Tacoma Way not eligible for listing in the NRHP or WHR under any criteria.

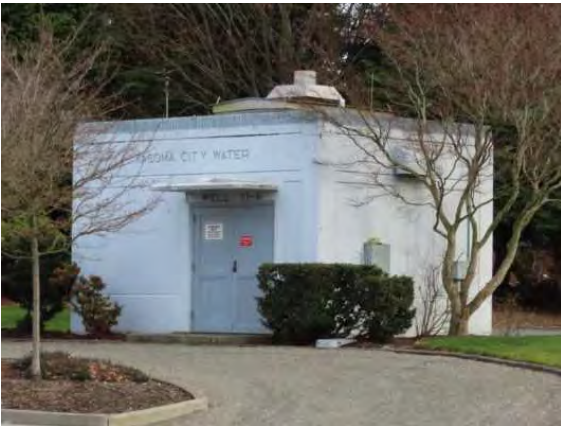
Wellhouse 11A at 4331 S Tacoma Way, view northeast.

Well and wellhouse 11A (1952): Wellhouse 11A sits on a poured-concrete foundation, is constructed of poured concrete, and is topped by a flat roof with systems, possibly venting, above. The building's facade includes an off-center concrete stoop with double pedestrian doors, signage above the doors reading "Well 11-A," and a concrete awning. The facade includes a date stamp in the lower northwest corner and incised ornament including textured panels, a cornice line, ridges at the roofline, and signage above the entry reading "Tacoma City Water." The building's north elevation includes an exterior pipe and additional incised ornament. The rear (east) elevation includes incised ornament and a vent. The south elevation includes incised ornament, an additional vent, and electrical.

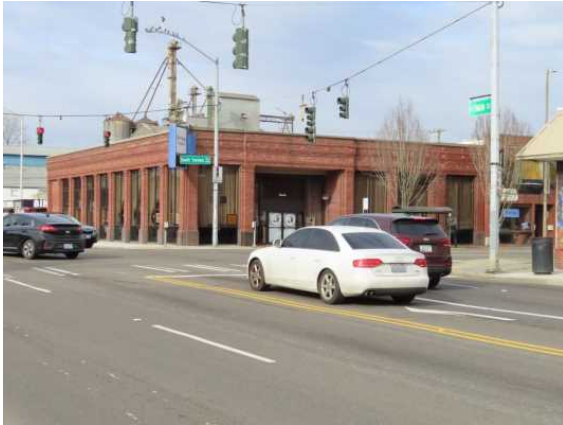
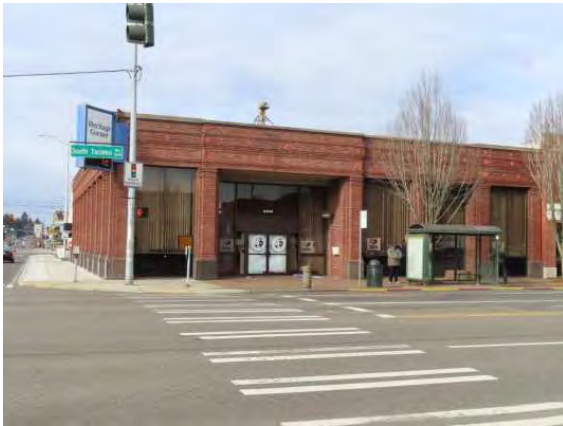
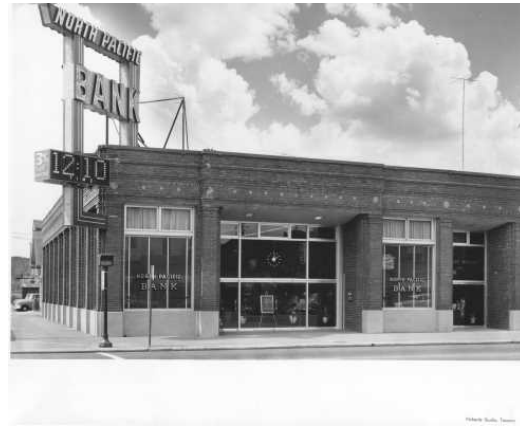
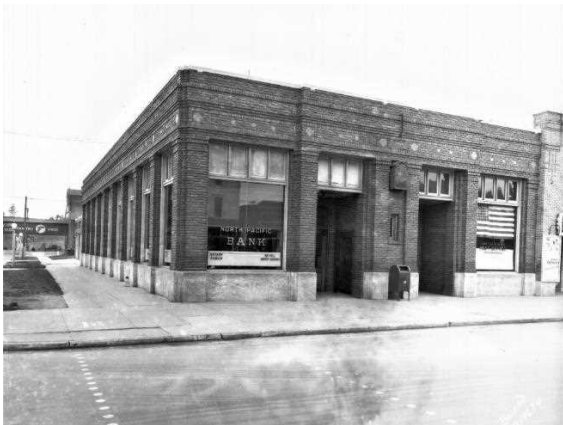
Bank at 5448–5450 S Tacoma Way

North Pacific Bank at 5448–5450 S Tacoma Way

According to the Pierce County Assessor, the bank building at 5448–5450 S Tacoma Way was constructed in 1914 (Pierce County Assessor 2023). The building is rectangular in plan, one story tall, and its facade faces east toward S Tacoma Way. It sits on a poured-concrete foundation, is clad in running-bond brick with stone at the base and large inset windows, and is topped by a flat, built-up roof. The ornamented cornice includes brick in projecting courses, rows of header bricks, and tile diamonds. A projecting corner sign reads “Heritage Corner.”

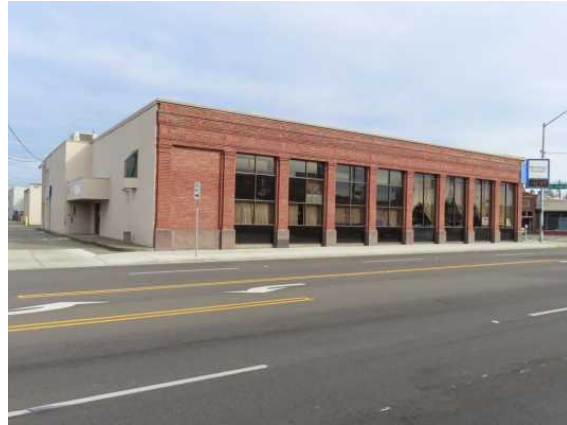
Bank at 5448–5450 S Tacoma Way

Due to its significance under Criterion C, HRA recommends the former bank building at 5448–5450 S Tacoma Way eligible for listing in the NRHP, WHR, and TRHP. The building’s period of significance dates to its construction in 1914, and the boundaries of the eligible resource are defined by the boundaries of the historic and present tax parcel.

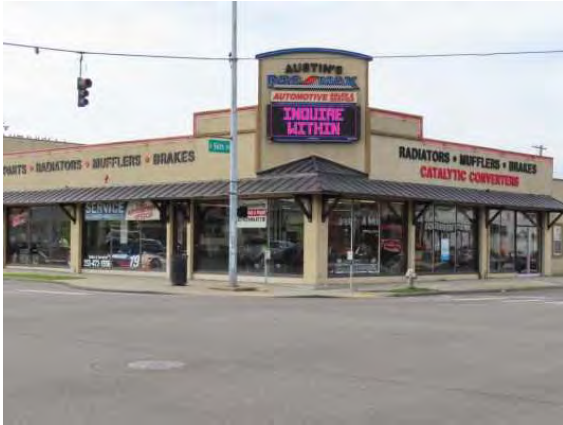
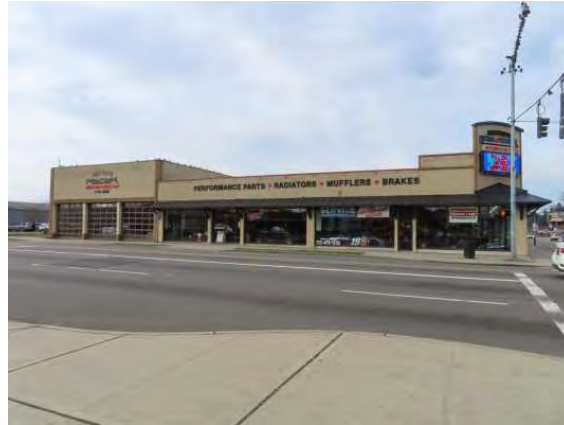
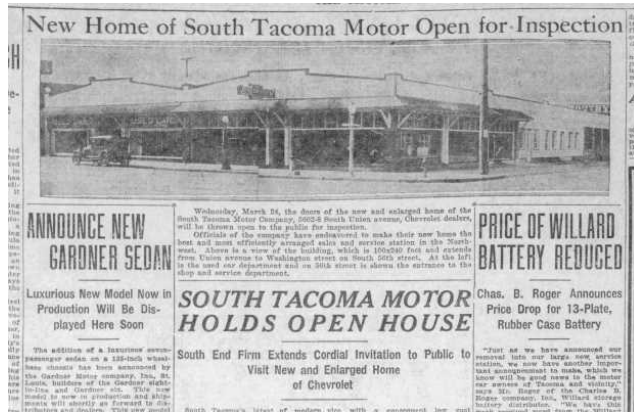
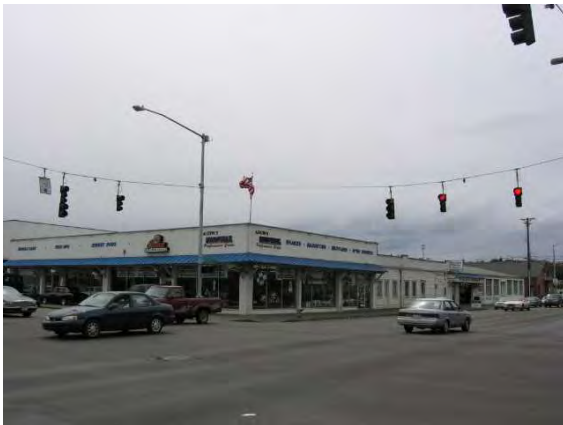
5602 S Tacoma Way

5602 S Tacoma Way Historic photo

NE Corner

According to the Pierce County Assessor, the large commercial building at 5602 S Tacoma Way was constructed as a service garage and showroom in 1925 (Pierce County Assessor 2023). The building sits on the prominent southwest corner of the intersection of S Tacoma Way and S 56th Street. It is rectangular in plan, made up of numerous separate masses with varied rooflines. Its primary elevations face both east and north. The building sits on a poured-concrete foundation, is constructed primarily of brick piers with walls of window glass topped by stucco parapets and standing-seam metal eaves. Parapets are oversized, stepped, and lined in neon. Applied signage reads “Austin’s Pro/Max Automotive Sales & Service.”

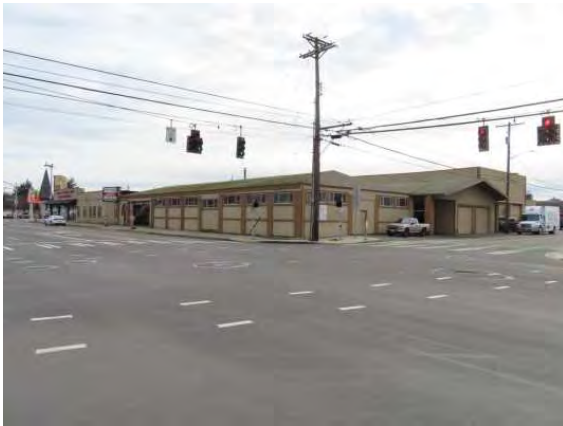
5602 S Tacoma Way

The building has lost significant integrity and no longer expresses its significance as an early twentieth-century commercial building associated with the early years of Tacoma's auto row. In spite of its significance under Criteria A and B, due to integrity loss, HRA recommends that the building at 5602 S Tacoma Way does not qualify for listing in the NRHP, WHR, or TRHP under any criteria.

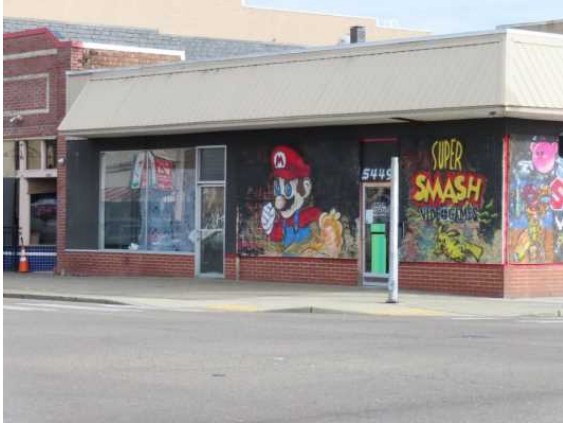
5447-5449 S Tacoma Way

From its period of construction (1920), the one-part commercial block at 5447–5449 S Tacoma Way retains integrity of location and setting, as it continues to function from a prominent corner on S Tacoma Way. The building has been heavily altered by the redesign of its entry, the replacement of all windows and doors, including transoms, the loss of original signage, the addition of a partial second story, incompatible siding, incompatible eaves, and the covering of original window openings. It does not retain integrity of design, materials, or workmanship. Additionally, it lacks integrity of feeling or association, as it no longer serves as a retail store on a shopping strip.

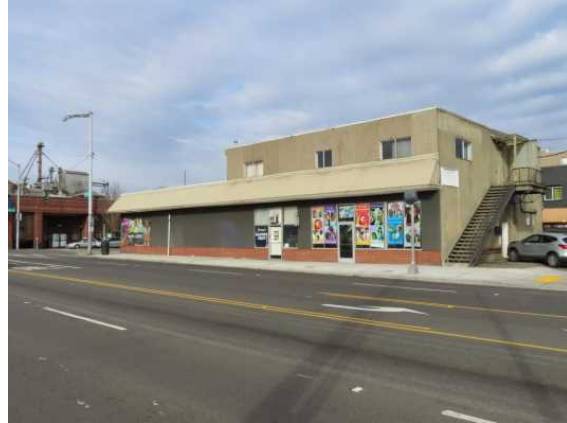
5447-5449 S Tacoma Way

**Physical description:** According to the Pierce County Assessor, the commercial block at 5447–5449 S Tacoma Way was constructed in 1920 (Pierce County Assessor 2023). The building is rectangular in plan, two stories tall at the rear and one story at the facade, and faces west toward S Tacoma Way. The building sits on a poured-concrete foundation and includes walls partially clad in running-bond brick at the base. Secondary walls are clad in pebble-dash, and the facade includes walls that are likely glazed but currently covered in painted plywood. The building is topped by a flat, built-up roof with deep standing-seam metal eave.

Due to a lack of significance and integrity, HRA recommends the building at 5447–5449 Tacoma Way not eligible for listing in the NRHP, WHR, or TRHP under any criteria.

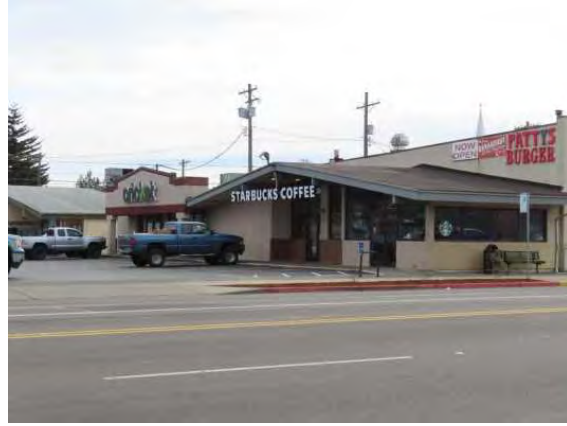
3512-3514 S 56th Street

The building sits on a poured-concrete foundation, is clad in stucco, and is topped by a standing-seam metal roof. The eastern storefront, used by Cricket Wireless, includes a stepped, central projecting parapet supported by concrete pillars. The parapet supports applied signage. Walls are stuccoed and surround an entry consisting of a single pedestrian entry door flanked east and west by full-height windows topped by transoms. No other fenestration is visible. To the west of the Cricket storefront is a Starbucks Coffee outlet with a shallow gable roof with deep eaves and visible rafter tails, which shelters two entries, both with glazed pedestrian doors paired with metal-frame windows topped by full-height transoms. The building's west elevation includes metal-frame windows. On the building's south elevation, it abuts an additional commercial building.

Due to a lack of significance and integrity, HRA recommends the building at 3512–3514 S 56th Street not eligible for listing in the NRHP, WHR, or TRHP under any criteria.

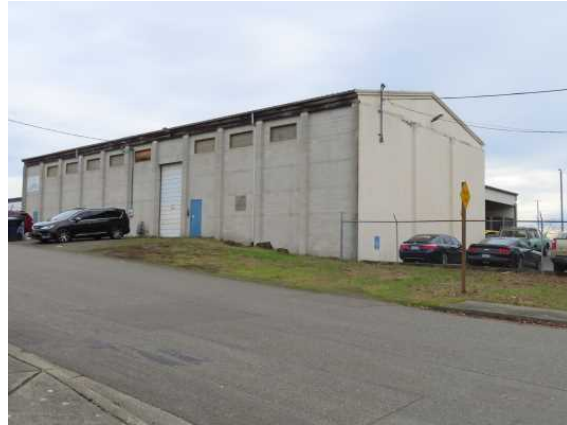
5801 S Adams Street

Due to a lack of significance and integrity, HRA recommends the building at 5801 S Adams Street not eligible for listing in the NRHP, WHR, or TRHP under any criteria.

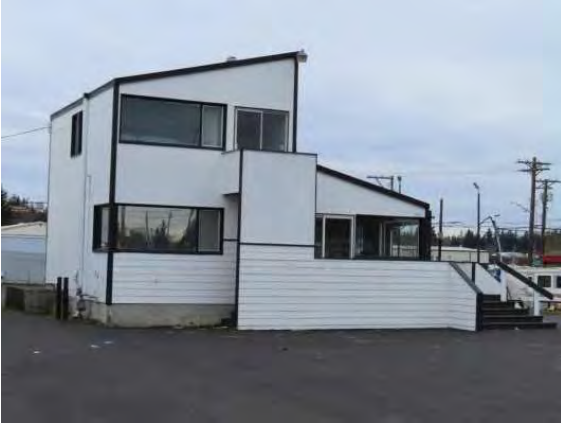
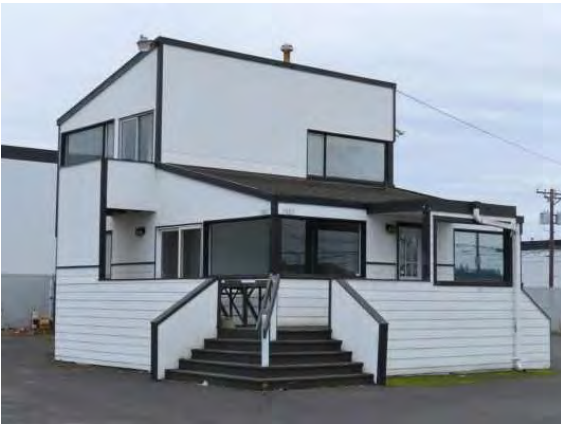
5802 S Tacoma Way

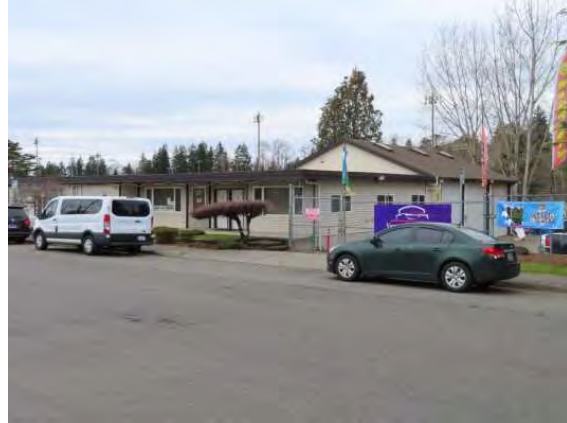
5812 S Adams Street

According to the Pierce County Assessor, the building at 5812 S Adams Street was constructed as a storage warehouse and office building in 1957 (Pierce County Assessor 2023). The building is a single story, square in plan, and faces east toward S Adams Street. The building sits on a poured-concrete foundation, is clad in cement boards, and is primarily topped by a flat built-up roof. The building's northwest corner is topped by a front-gabled roof covered in shingles with sidelights.

Due to a lack of significance and integrity, HRA recommends the building at 5812 S Adams Street not eligible for listing in the NRHP, WHR, or TRHP under any criteria.

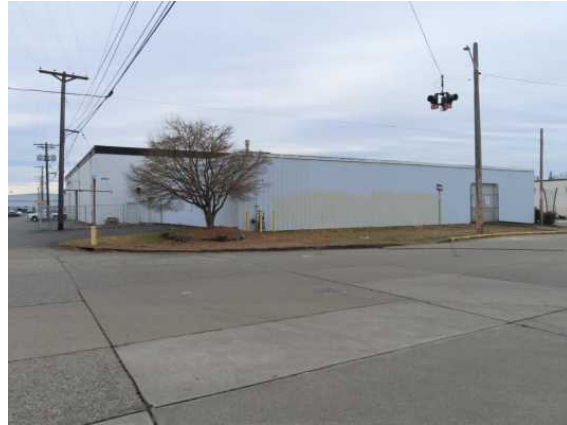
5802 S Washington Street

The original warehouse, located at the north end of the parcel, is a single-story, rectangular mass. To the south, the taller added warehouse abuts the original, giving the building a generally rectangular, single-story plan. The building sits on a poured-concrete foundation, includes walls of concrete block and walls of smooth concrete (south warehouse), and walls clad in ribbed-metal panels (north warehouse). Both masses are topped by flat roofs.

Due to a lack of significance and integrity, HRA recommends the warehouse at 5802 S Washington Street not eligible for listing in the NRHP, WHR, or TRHP under any criteria.

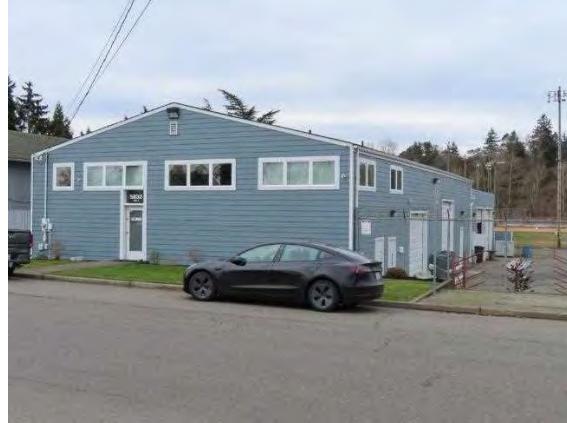
5832 S Adams Street, view southwest.jpg

The single-story building faces east toward S Adams Street. It is rectangular in plan, sits on a poured-concrete foundation, is clad in cement boards, and is topped by a front-gabled, asphalt shingle roof with no eave.

Due to a lack of significance and integrity, HRA recommends the warehouse at 5802 S Adams Street not eligible for listing in the NRHP, WHR, or TRHP under any criteria.

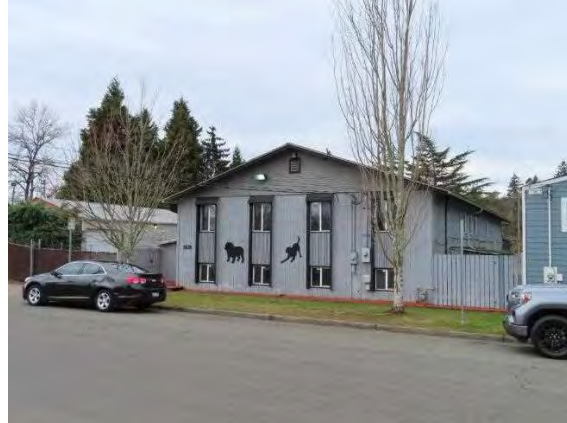
5838 S Adams Street, view southwest.jpg

The two-story building at 5838 S Adams Street is two stories tall, L-shaped in plan, and faces a fenced-in parking lot or yard. The building sits on a poured-concrete foundation, is clad in T1-11, and is topped by a cross-gabled asphalt shingle roof. The building's east-facing facade includes two floors of vinyl-frame sliding windows separated by panels of narrow vertical boards. The four bays of windows are enframed and topped by shallow eaves of lapped boards. Above the window bays, the gable is filled with narrow, lapped boards. Two wood silhouettes of dogs have been applied between two of the window bays. The building's south elevation includes a stoop and entry door at the southeast corner topped by enframed vinyl-frame windows. South of the entry is a single-story, shed-roofed projection topped by an additional window. The projection, along with privacy fencing, encloses the side yard but leaves the entry open and accessible. To the rear of the building is another projection and a wing including a pedestrian door and a garage bay with overhead door. The north elevation, minimally visible from the public ROW, includes additional vinyl-frame windows on the upper floor.

Due to a lack of significance and integrity, HRA recommends the warehouse at 5838 S Adams Street not eligible for listing in the NRHP, WHR, or TRHP under any criteria.

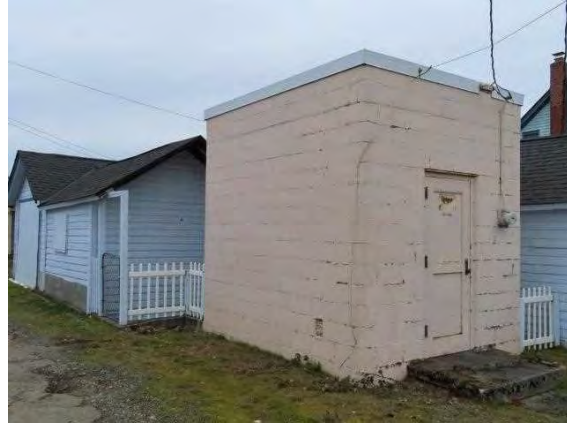
3509 S 60th Street, view northeast.jpg

Due to a lack of significance, HRA recommends the utility building at 3509 60th Street not eligible for listing in the NRHP, WHR, or TRHP under any criteria.

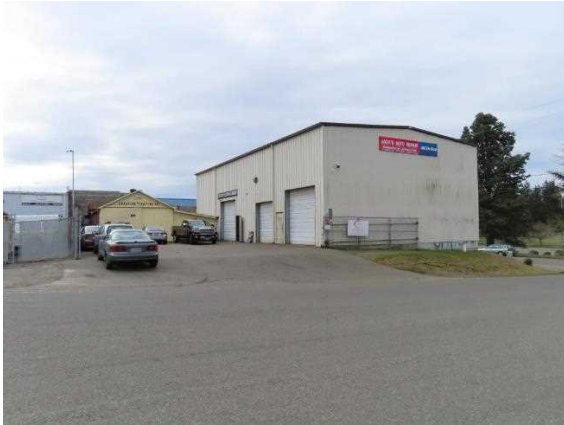
3762 S 60th Street, view south.jpg

3762 S 60th Street, view east.jpg

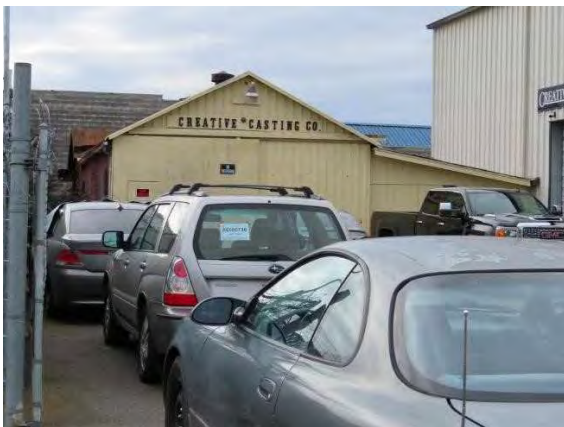
3762 S 60th Street, also view south.jpg

Category	Item
Foundation	Concrete - Poured
Form Type	Utilitarian
Roof Type	Gable - Front
Roof Type	Gable - Side
Roof Material	Metal - Corrugated
Cladding	Metal
Structural System	Wood - Platform Frame
Plan	Irregular

Today the building is dominated by the large, rectangular warehouse attached by a shed-roofed, covered walkway to the earlier single-story, front-gabled building. The ca. 1998 warehouse sits on a poured-concrete foundation, is clad in ribbed-metal panels, and is topped by a shallow, metal roof. Its east-facing elevation includes three garage bays, two of which are oversized, with overhead garage doors, and two pedestrian doors. At the building's southeast corner, it is attached to the 1956 warehouse on a poured-concrete foundation, clad in ribbed-metal panels, with a sliding wood door on casters. The sliding door includes a pedestrian door. Above the entry on the 1956 warehouse is applied signage for "Creative Casting Co." The 1956 warehouse is topped by a corrugated metal roof. The ca. 1998 warehouse's north elevation includes no fenestration, and its west elevation includes one wide, fixed window on the lower floor and three fixed windows on the upper floor. At the rear (south) of the parcel, secondary elevations of the 1956 warehouse are minimally visible but include a projection to the west with a shed eave over a workspace. One additional building is located at the rear of the parcel but is not documented in assessor's records. It is a front-gabled garage, facing west. It is clad in wood siding and includes a sliding garage door on casters. No other fenestration is visible. It is topped by a corrugated metal roof.

Due to a lack of significance and integrity, HRA recommends the industrial building and garage at 3762 S 60th Street not eligible for listing in the NRHP, WHR, or TRHP under any criteria.

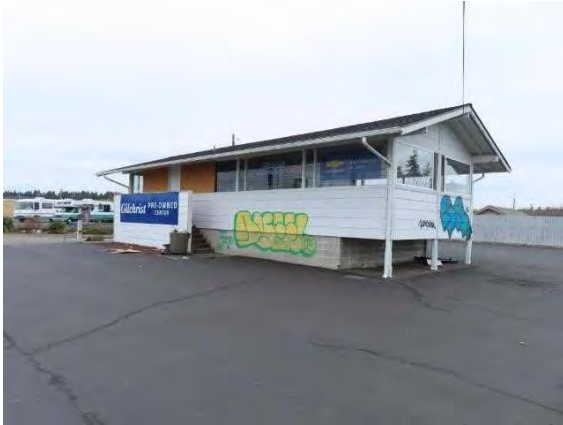
6001 S Tacoma Way, view northeast.jpg

Category	Item
Foundation	Concrete - Block
Form Type	Commercial - Strip Commercial
Roof Type	Gable - Side
Roof Material	Asphalt/Composition - Shingle
Cladding	Fiber Cement Board
Structural System	Wood - Platform Frame
Plan	Rectangle

According to the Pierce County Assessor, the commercial building at 6001 S Tacoma Way was constructed in 1966 (Pierce County Assessor 2023). The building is rectangular, a single story, and faces west toward S Tacoma Way. The building sits on a concrete-block foundation, is clad in cement boards, and is topped by a side-gabled, asphalt shingle roof with deep eaves and visible rafter tails.

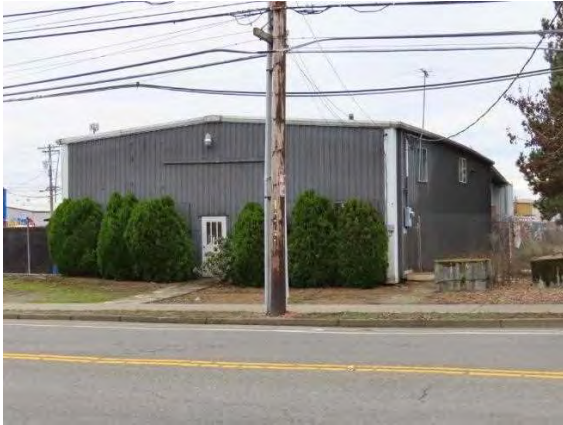
6602 S Adams Street, view southeast.jpg

Category	Item
Foundation	Concrete - Poured
Form Type	Commercial - One-Part Block
Roof Type	Gable - Side
Roof Material	Metal
Cladding	Metal
Structural System	Wood - Platform Frame
Plan	Rectangle

From its period of construction (1968), the building at 6602 S Adams Street retains integrity of location and setting, as it remains on its original parcel. It does not retain integrity of design, materials, or workmanship, as evident alterations include incompatible window replacements and the addition of a carport ca. 2005 (NETROnline 2023). The building does retain integrity of feeling and association, as it continues to serve a commercial purpose.
