Stride program

I-405 corridor

Figure 1
South Renton Transit Center and Roadway Improvements Project
Area of Potential Effects and Area of Potential Ground Disturbance

Figure 14
Locations of Geotechnical and Geoarchaeological Bores for the South Renton Transit Center and Roadway Improvements Project

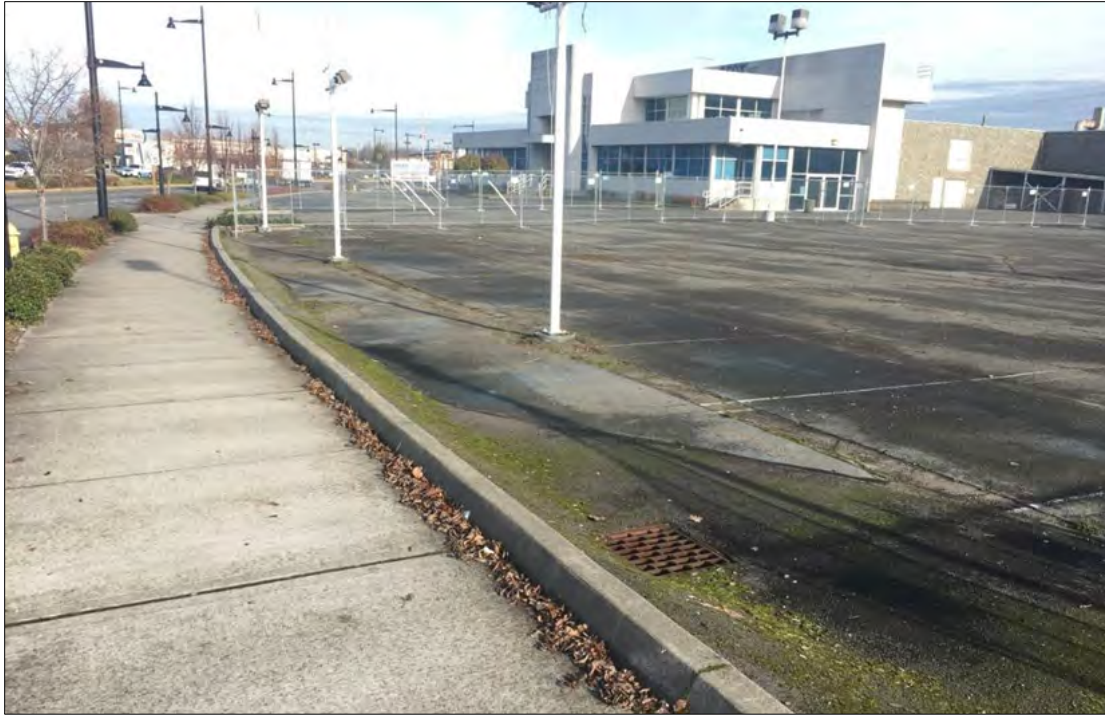
Figure 12
Overview of western portion of planned South Renton Transit Center; view to north

The project is within an area that has been extensively developed and urbanized and is currently for car sales and repair businesses (Figure 12). Very few non-paved areas exist, and these are confined to small grass and planting strips. This area has been at least superficially graded flat for use as parking area as well as extensively disturbed at the location of multiple buildings. Buried utilities are prevalent along the street margins (Figure 13) as well as occasionally extending across the site, feeding multiple buildings and light poles. Large aboveground power lines are located at the southern end (oriented east/west), as well as along the eastern end (oriented north/south). The area appears to be at or near the historic/native ground surface (no major grade changes with neighboring properties), but is 99 percent paved. Based on results of the pedestrian survey, Sound Transit and ESA determined that subsurface survey with hand tools was not feasible.
